COMBINED FIRE AND HEALTH & SAFETY RISK ASSESSMENT.

| Address of premises: | 62-72 Keswick House Eastbury Way Swindon SN25 2EW |
| Date of fire risk assessment: | 28 th August 2024 |

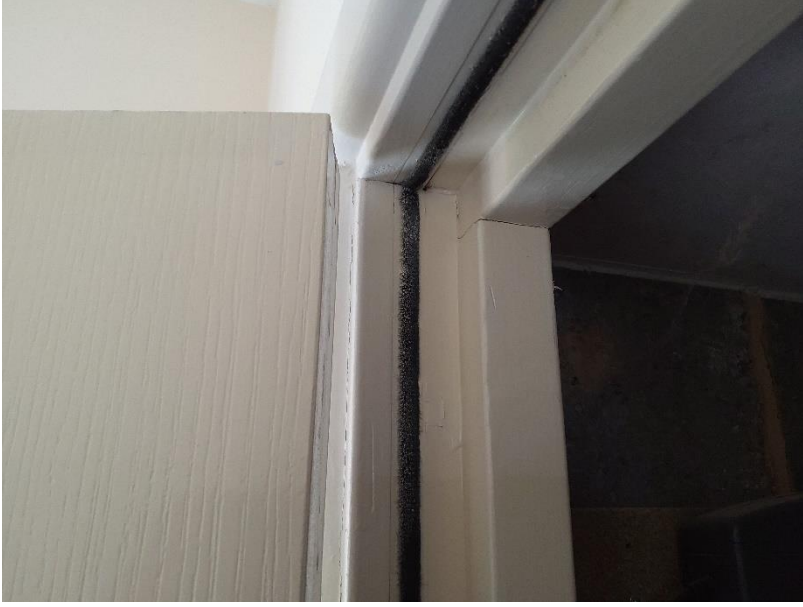
| <p>06</p> | <p>It was noted during this fire risk assessment that the cold smoke seals within all riser cupboards were partially painted which could affect the integrity of the seal allowing smoke to pass into the means of escape. It is therefore recommended that the RP instructs a suitably qualified and competent contractor to replace the painted seals with new combined cold smoke and intumescent seals.</p> | <p>3</p> | <p>B</p> | <p>Action required RP to consider replacement</p> |

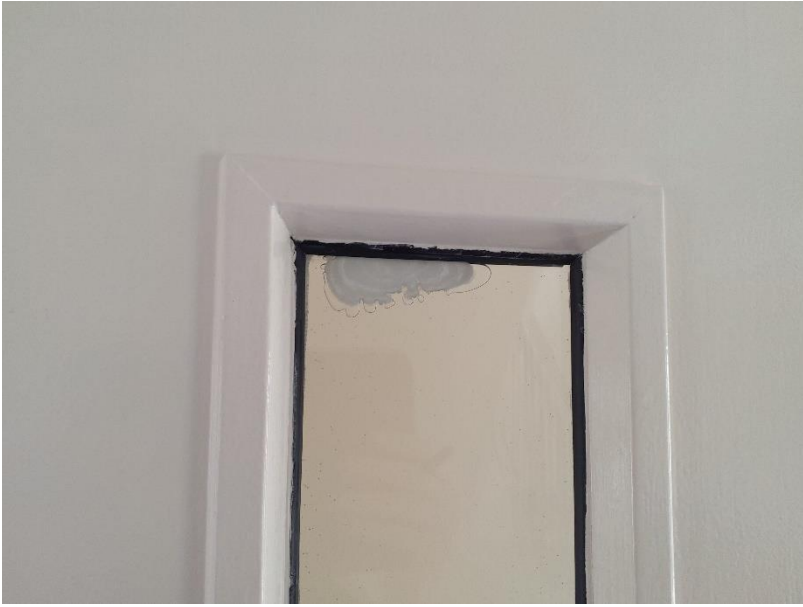
| <p>07</p> | <p>It was noted during this fire risk assessment that the glazing in the top panel of the ground floor lobby door appeared to be damaged and the integrity of the fire resistance could not be verified. It is therefore recommended that the RP instructs a suitably qualified and competent contractor to replace the glazing with new fire rated glazing capable of providing a minimum of 30 minutes fire resistance in accordance with "Fire Safety (England) Regulations 2022: Fire Door Guidance Article 6.7D and 6.9".</p> | <p>2</p> | <p>C</p> | <p>Action required RP to consider replacement</p> |

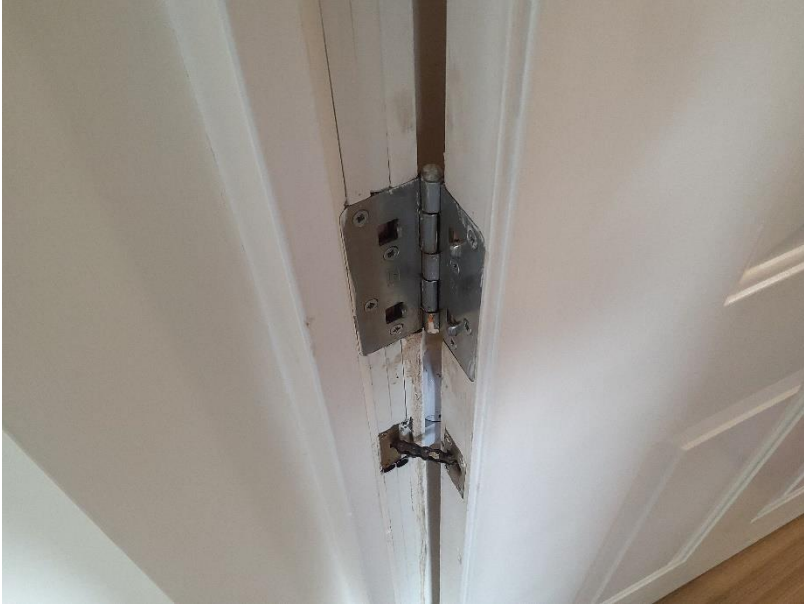
| 08 | <p>As per section 33.2 of Fire Safety in Purpose-Built Block of Flats a type 1 fire risk assessment requires us to conduct a fire door survey on a sample of flat front doors. The door to Flat 62 was surveyed during this sample the door appeared to be a notional fire door with intumescent seals only, three non-fire rated hinges and a perkomatic closer. Consideration could be given by the RP to replace the intumescent seal with a combined cold smoke and intumescent seals and hinges be replaced with high melting point hinges in order to enhance escape route protection. It was further noted that all riser fire doors were also fitted with three non-fire rated hinges. The same consideration could be given by the RP to replace all hinges with high melting point hinges.</p> | 3 | B | <p>Action required</p> <p>Upgrades to be considered</p> <p>This assessment made available to all owners</p> |

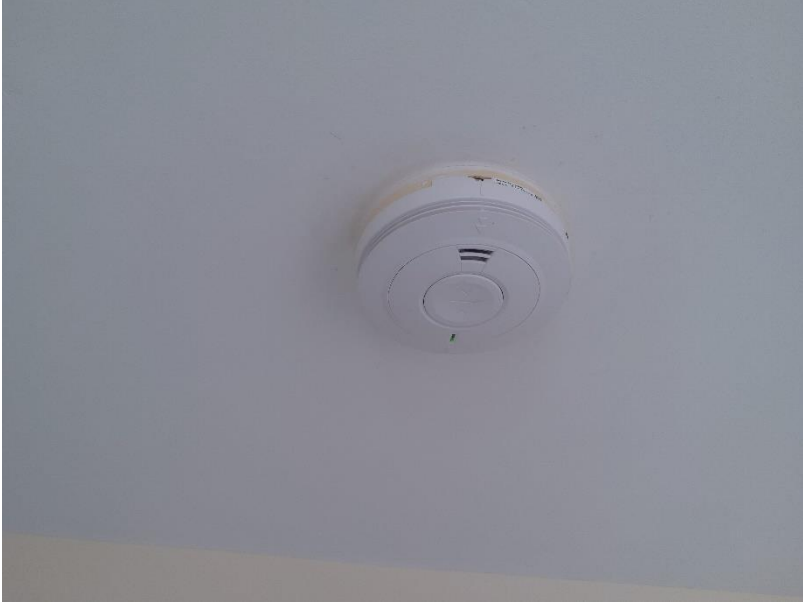
| 10 | <p>It was noted during this fire risk assessment that hard wired smoke detectors were installed within the premises. This could be considered as an overprovision for this purpose-built block of flats implementing a stay put evacuation policy as per "Fire Safety in Purpose Built Blocks of Flats: Section 20". Consideration could be given by the RP as to their removal.</p> | 3 | C | <p>Action required</p> <p>RP to consider removal</p> |

| | <p>It was noted during this fire risk assessment that hard wired smoke detectors were installed within the premises. This could be considered as an overprovision for this purpose-built block of flats implementing a stay put evacuation policy as per "Fire Safety in Purpose Built Blocks of Flats: Section 20". Consideration could be given by the RP as to their removal.</p> <p>Each flat is responsible for their own fire precautions and it is recommended that the RP advise each resident of the importance of installing smoke detectors within their flat. One battery operated smoke detector in the lobby of each flat would be the minimum provision, however mains powered smoke detectors, each with a battery backup, installed within the escape route of each flat, in all rooms that communicate with the escape route and a heat detector within the kitchen, interlinked to form a BS5839-6: 2019 Grade D detection system with LD2 coverage would be the preferred and safest option for each occupant.</p> | |
